# Monitoring system for the construction of buildings in the area of mining exploitation impact

Observations of building structures in mining areas, reveal the occurrence of periodic and permanent excessive loading situations. These include ground deformations associated with the extraction of underground mineral deposits. In urban areas, these deformations significantly alter the operating conditions of building structures. For this reason, forecasts of ground transformation and analyses of possible changes in the technical condition of buildings on the ground surface are made in advance, even before mining is commenced. Taking into account previous in-house experience of the observed effects of mining impacts on building structures, an original method of monitoring changes in the condition of these structures has been developed. The aim of the monitoring is to record phenomena that change the operating conditions of the structures. In the developed method, measurements are made quasi-continuously using strain and deflection sensors mounted directly on structural elements. In the mining area affected by the mining operation being carried out in the years 2020 - 2022, and with a f

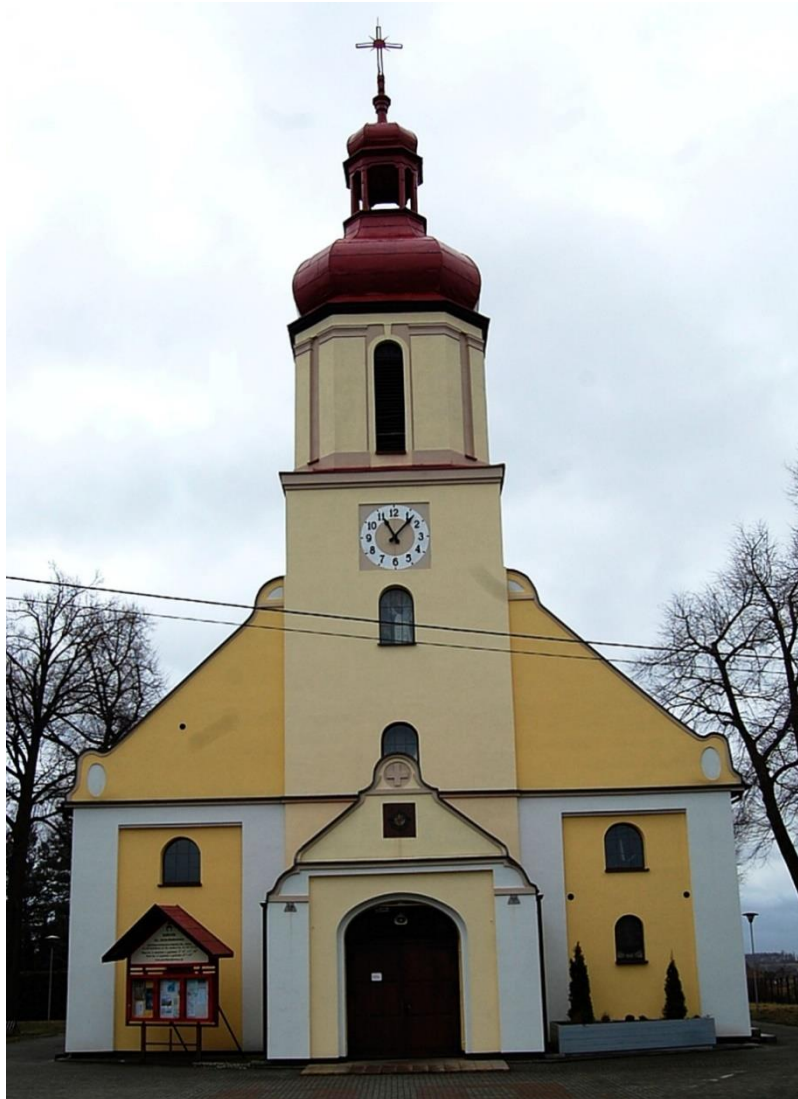
Structure B - is a church building, built around 1922 on a single nave plan, with a bell tower on the side of the main entrance (Fig. 4).

**Fig. 4** Structure B of the testing ground - church building, visible bell tower and main entrance

The length of the church building, including the chancel and vestibule, is approximately 41.50 m, with a nave width of approximately 17.00 m. The height of the bell tower structure is approximately 27.70 m. The above-ground part of the building is built in traditional masonry construction. The foundations of the church are made of rubble stone, the walls of burnt brick with lime mortar. The ceiling over the nave is wooden, suspended from the wooden roof truss. The bell tower is brick in the lower part and wooden in the upper part. The nave side of the tower has a choir balcony, which is of reinforced concrete, supported partly on the masonry wall of the tower and partly on two brick columns. The staircase to the choir and in the lower part of the tower is reinforced concrete; in the higher part of the tower it is wooden, ladder-like. The church structure has been reinforced with a reinforced concrete ring around the nave, external pilasters and internal tie-beams in the ceiling plane.

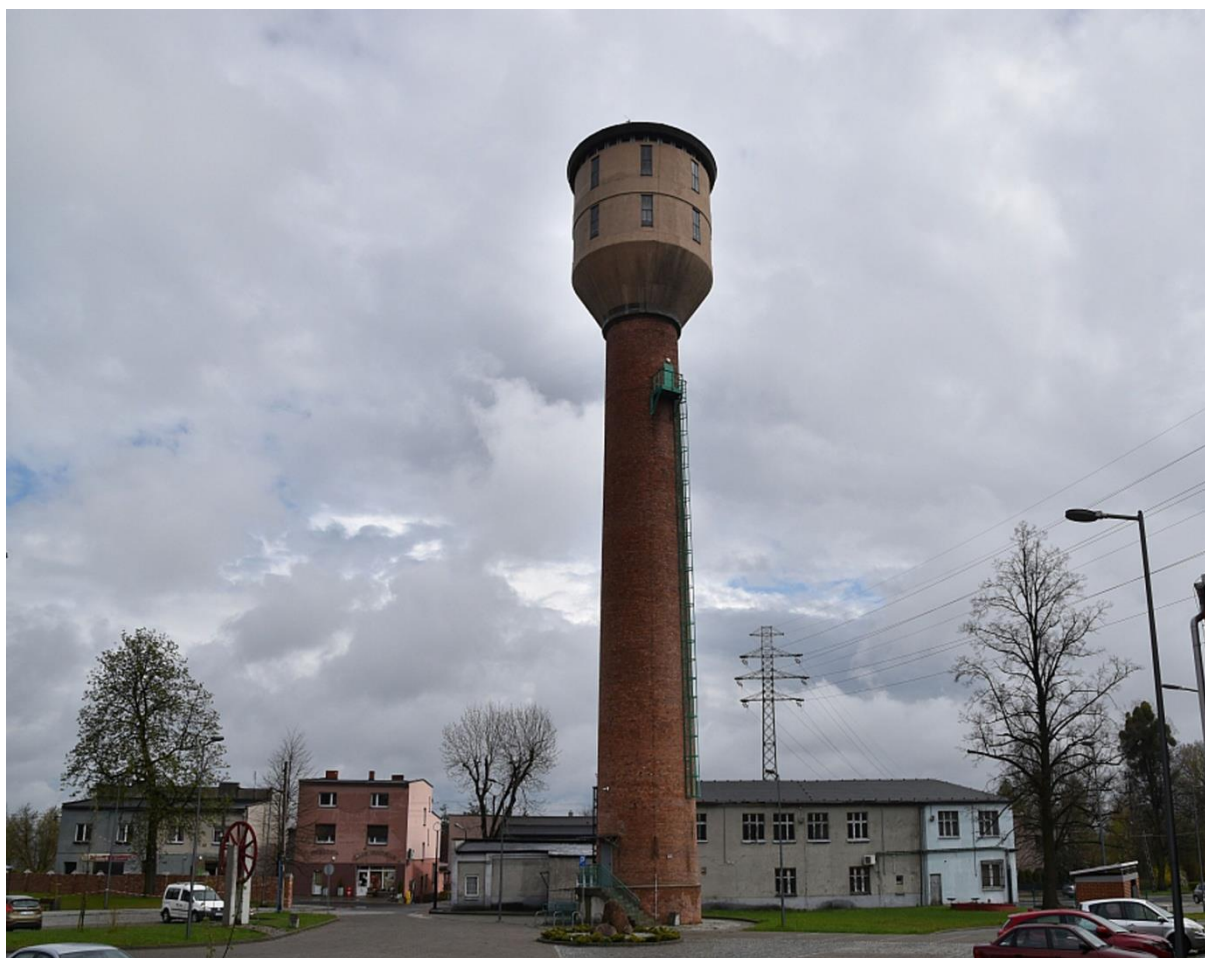
Structure C - is a viewing tower, opened to the public after the post-mining facilities were rehabilitated (Fig. 5).

**Fig. 5** Structure C of the testing ground - view of the viewing tower after the rehabilitation of the industrial water tower

The tower structure is the remains of a brick chimney built around 1880. In 1952, as part of an adaptation, the height of the chimney was reduced and a steel industrial water tank was installed on top. The structure served as a water tower until 1994. Today, the tower is open to the public as a viewing point. The core of the tower, made of solid brick, is 35.00 m high. The outer diameter at the base is 6.00 m, with a wall thickness of 1.00 m. At the level of the top of the shaft, the diameter is 4.60 m and the wall thickness is 0.50 m. The tank has an internal diameter of 8 m. The total height of the structure, the tower including the tank, is 45.00 m. Inside the core of the tower, there is an accessible staircase leading to the viewing platform.

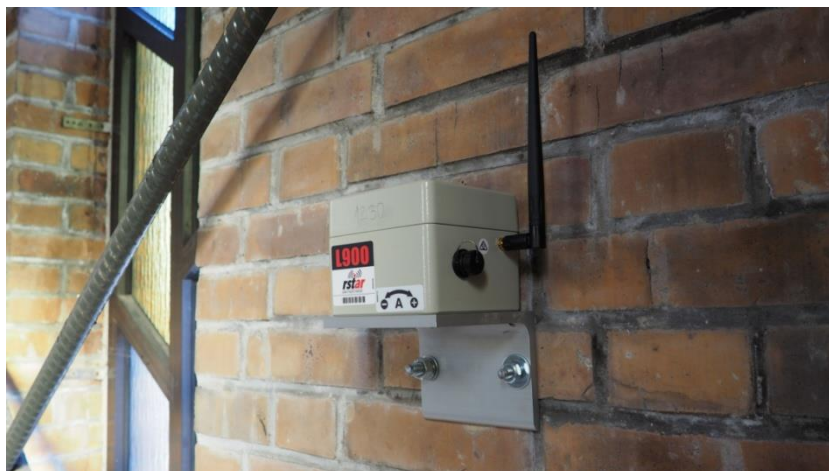
The system installed on the structures performs automatic measurements at a user-defined frequency of every 6 hours. The measured quantities are the sine values of the tilt angles in two planes (TILT 1, TILT 2). The sine values are provided with an accuracy of up to 6 decimal places. Proper mounting of the sensor using a custom-made steel bracket (Fig. 6) ensures that the measurement yields the sine values of the tilt angles in the axis parallel and

perpendicular to the wall to which the sensor is attached. This enables the determination of the tilt magnitude and the calculation of the tilt vector direction. The measurement readings are then converted into appropriate units, such as angle measurement in degrees or tilt in millimetres per metre [mm/m].

**Fig. 6** Biaxial tilt sensor - visible mounting method using a steel bracket anchored to the wall of the structure
